# INVESTIGATION OF HOLE PREPARATION AND FASTENER INSTALLATION FOR GRAPHITE/EPOXY LAMINATES

McDonnell Aircraft Company  
McDonnell Douglas Corporation  
P.O. Box 516  
St. Louis, Missouri 63166

August 1980

Technical Report N00019-79-C-0293  
Final Report for Period 1 November 1979 - 29 August 1980

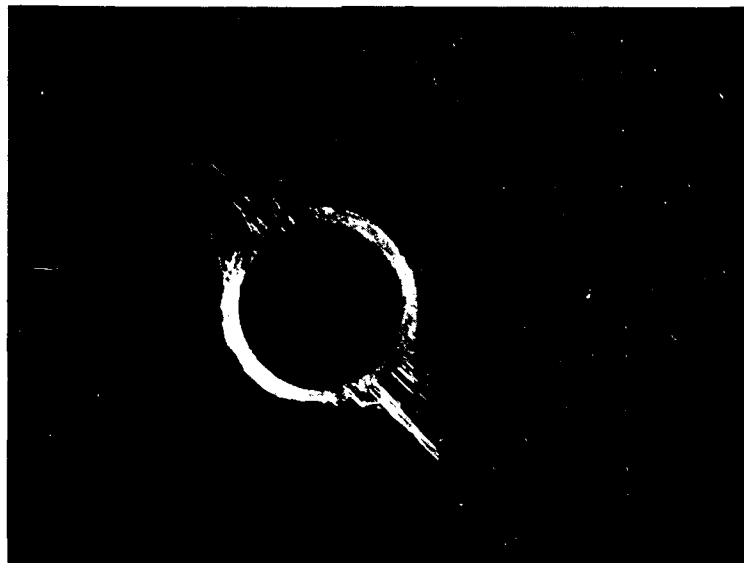
**Figure 21. Anomaly-E, Delaminations Interply Exit Side (After Drilling) (10X)**

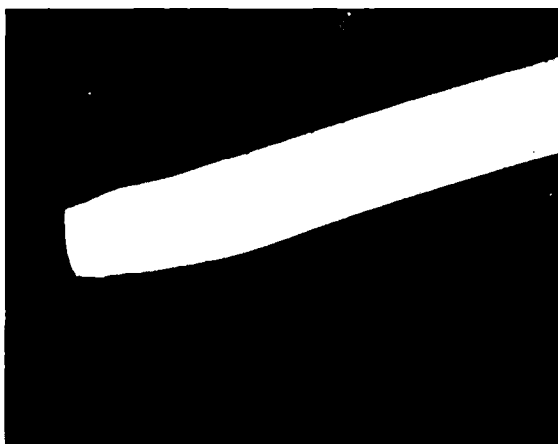
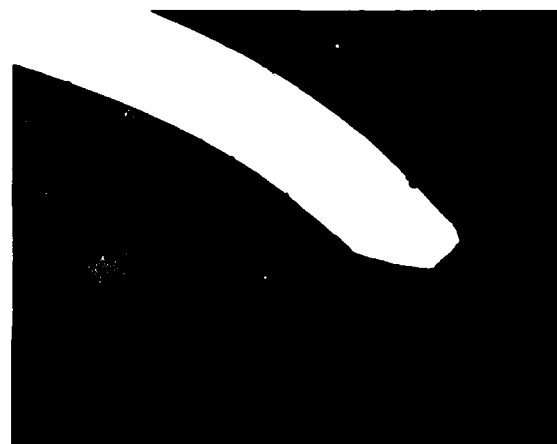
Specimen No. 11 (50X Before Printing)

Specimen No. 12 (50X Before Printing)

- o Fastener installation tests demonstrated that solid rivets and flush head blind bolts should not be installed in Gr/Ep since damage is likely.
